Report Number: J240313001-1

EN 1634-1:2014/A1:2018

Fire Resistance Test for Doorset incorporating Building Hardwares

Guangdong Jinlian'an Technology Co., Ltd.

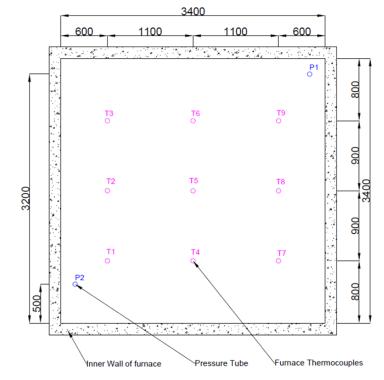
Figure 1 Location of Furnace Thermocouples and Pressure Sensors

The furnace opening size is $3.4 \times 3.4 \text{ m}$. 9 mineral insulated thermocouples, which were distributed uniformly in the furnace and were kept at $100 \pm 50 \text{ mm}$ away from the exposed surface of test specimen, were provided to monitor the mean temperature of the furnace.

The locations and reference numbers of the furnace thermocouples were shown in Figure 1.

Two pressure sensors were provided to monitor and control the furnace pressure after the first five minutes of testing the furnace atmospheric pressure so that it complied with the requirements of Clause 5.2 of EN 1363-1:2020. The pressure condition was assumed a linear pressure gradient of 8.5 Pa per 1 m and a neutral pressure axis at a height of approximately 0.5 m above the notional floor. The pressure at the top of test specimen was controlled within 20 Pa.

The locations and reference numbers of the pressure sensor were shown in Figure 1.

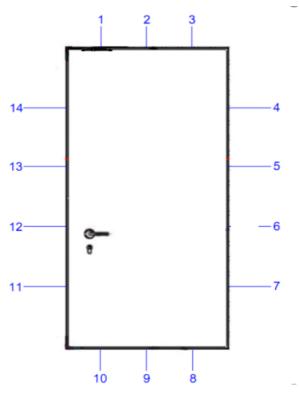
Figure 2 Initial Clearance Measurement Positions (View from unexposed side)

Ini	tial Cle	earanc	es at	positio	ons				
1	2	3	4	5	6	7	8	9	10	11	12	13	14
1.5	1.7	1.5	1.5	1.4	1.5	1.7	1.7	2.0	1.5	1.7	1.2	1.4	1.4

All dimensions are in mm.

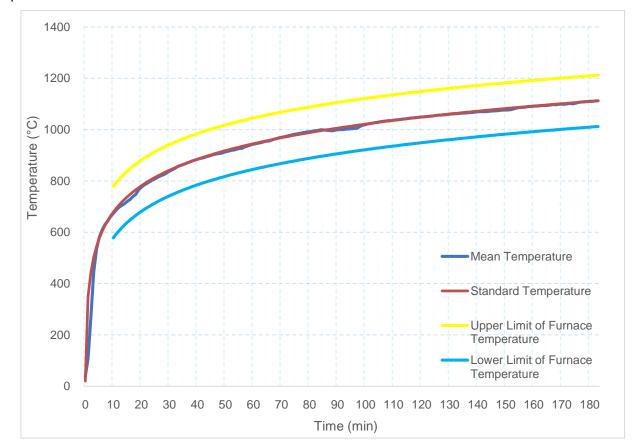
Graph 1 Furnace Mean Temperature / Time Curve

The mean furnace temperature recorded was plotted against time in Graph 1 with the specified curve for comparison.

The mean furnace temperature and standard temperature was recorded in Table 3 for comparison. Table 3 Furnace mean temperature and standard temperature (Unit: °C)

Time	Mean	Standard	Diff%	Ambient Temp.	
Min	Temp.	Temp.			
0	38.0	20.0	/	31.8	
20	775.6	781.4	-4.6	32.5	
40	884.3	884.7	-2.2	32.5	
60	943.2	945.3	-1.5	33.0	
80	992.3	988.4	-1.1	33.4	
100	1019.4	1021.8	-0.9	33.9	
120	1049.2	1049.0	-0.7	34.0	
140	1069.3	1072.1	-0.6	34.0	
160	1091.4	1092.1	-0.6	33.7	
183	1112.4	1112.2	-0.5	34.0

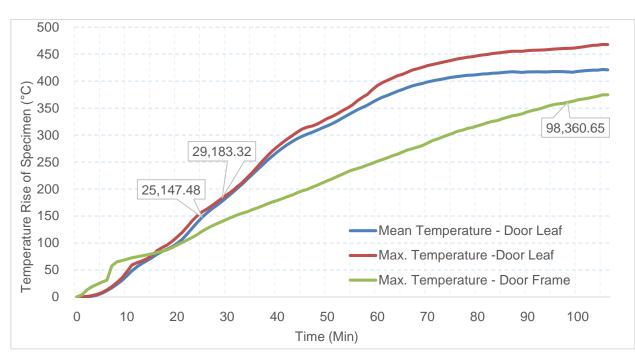
The mean and maximum temperatures raise of the unexposed face of the doorset were shown in Graph 2.

Graph 2 The mean and maximum temperatures raises/time curve of doorset The door leaf mean temperature rise for insulation (140°C rise) was exceeded after 25 mins. The door leaf maximum temperature rise for insulation (180°C rise) was exceeded after 29 mins. The door frame maximum temperature rise for insulation (360°C rise) was exceeded after 98 mins.

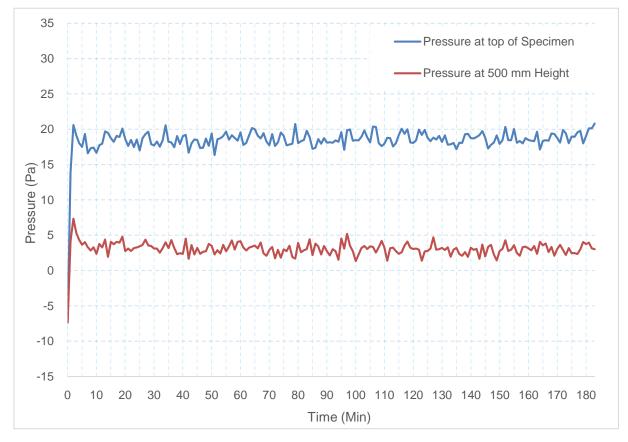
Graph 3 Furnace Pressure / Time Curve

The furnace pressure was recorded and shown in Graph 3.

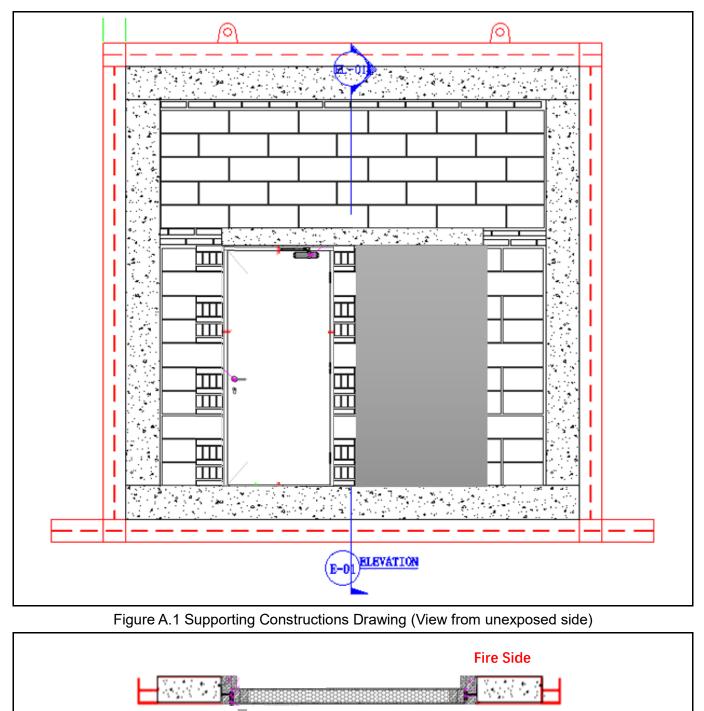
Figure A.2 Supporting Constructions Drawing (Plan view)

Wal	l	
•	1980 kg/m ³	
•	200 mm	
•	Cement: Sand	
• •	1:4	
	:	: 200 mm : Cement: Sand

The test doorset was builded into a specimen support system according to manufacturer's instruction by KAS. The test construction was shown in Appendix A, Figure A.1. The doorset was opening away from the heating conditions of test.

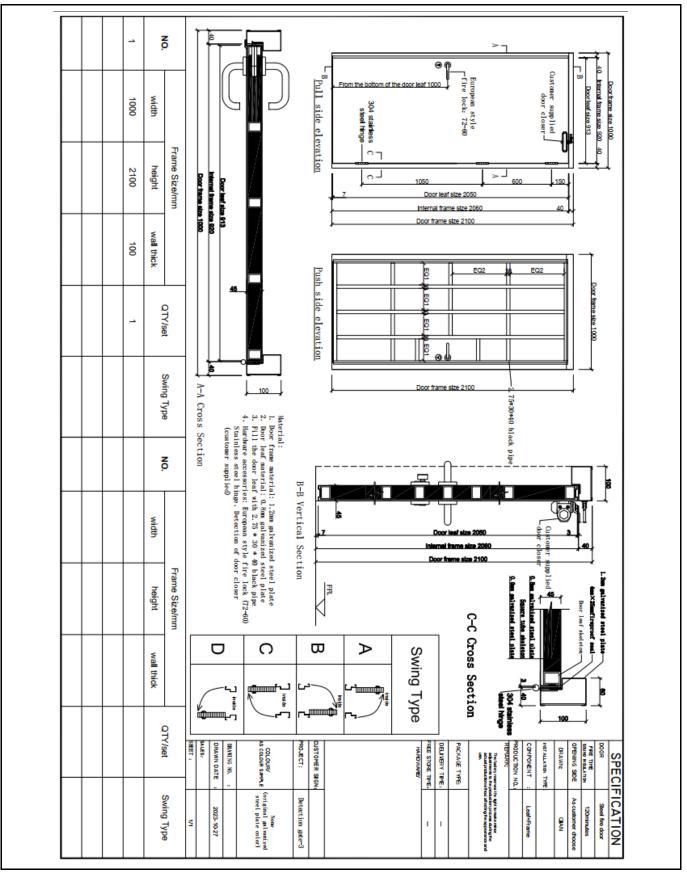
Figure B.1 Doorset drawing

The single leaf metal doorset had overall nominal dimensions of 2100 mm high x 1000 mm wide x 100 mm thick. The doorset incorporated a single door leaf of overall dimensions 2050 mm high x 913 mm wide x 45 mm thick, which comprised of a core of 40 mm thick Fire-resistant cotton, and sandwiched by 0.8 mm thick Galvanized steel sheet on both sides. The door leaf stiffeners were comprised of 30 x 40 x 2.75 mm thick Galvanized steel plate.

The door leaf was hung within the door frame by three stainless steel butt hinges 'LIKCOO / SS002'. The door leaf was provided with a lockset 'KinLong / SSN12730' which was incorporated a set of lever handle and a 70 mm long cylinder. The door leaf was provided with a door closer 'J-095', that was supplied by ' Guangdong Jinlian'an Technology Co., Ltd.', surface mounted on the right top of the unexposed side of the door leaf. The lockset was latched but unlocked during the test.

Refer to Figure B.1 to B.2, unless stated otherwise, all values are nominal, and all information in Table 1 is supplied by the client.

Door Leaf	Туре	Single leaf single swing steel doorset				
	Nominal Size	913 mm x 2050	0 mm x 45 mm *			
	Facing	Material:	0.8 mm thick Galvanized steel plate			
Door Leaf	Cara	Material:	Fire-resistant cotton			
	Core	Thickness:	40 mm			
	Stiffener	Material:	Galvanized steel plate			
	Sullener	Size:	30 x 40 x 2.75 mm			
	Material:	1.2 mm Galvanized steel plate				
Door Frame	Rebate:	20 mm *				
	Nominal Size:	2100 mm x 1000 mm x 100 mm *				
	Llinere	Brand:	LIKCOO			
Hardware	Hinge	Model:	SS002

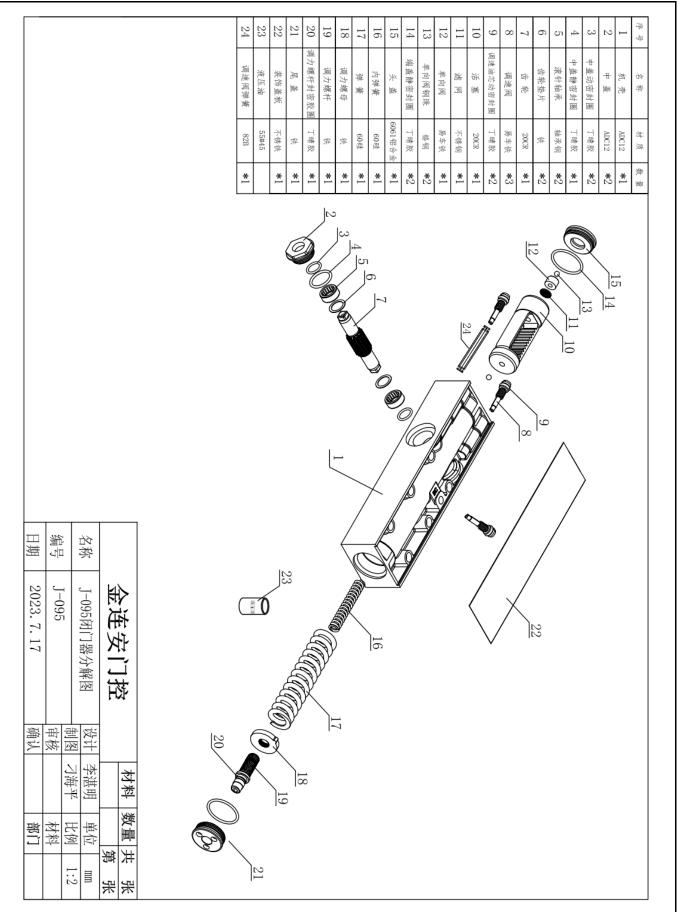
Figure B.2 Door closer drawing

Material:	Stainless steel 304
		Size:	3 nos. of 4" x 3" x 3 mm *
		Supplier:	LIKCOO LOCKS CO.LTD
		Brand:	KinLong
		Model:	SSN12730
	Lockset	Body size:	24 x 235 x 89mm
		Status during the test:	Latched but unlocked during the test *
		Brand:	KinLong Virtues
		Model:	SSN12730
	Lever handle	Material:	304 stainless steel
		Size:	54 x 141 x 60mm
		Brand:	KinLong
		Model:	SSN12730
		Material:	304 stainless steel
		Size:	70 mm
	Cylinder	Supplier:	Guangdong Kinlong Hardware Products Co., Ltd.
		Protection case material:	304 stainless steel
		Protection case size:	54 mm
		Supplier	Guangdong Jinlian'an Technology Co., Ltd
		Model:	J-095
	Door closer	Material:	Aluminum
		Size:	233 x 62 x 42 mm
		Location:	Installed at the unexposed side of door leaf
